Assessment of residences adjacent to rock blasting using NBR 9653 and NP 2074 in the city of Salgueiro - PE

Lucíolo Victor Magalhães e Silva¹

¹ Federal Institute of Sertão Pernambucano, CSAL-CTIED, Salgueiro/PE, Brazil. Email: luciolo.victor@ifsertao-pe.edu.br

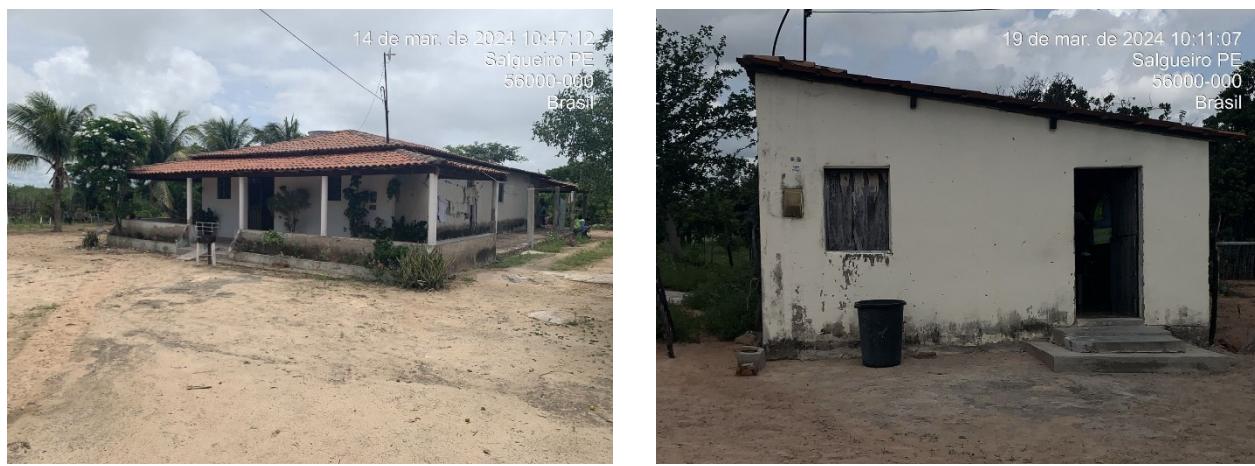
the)
Figure 1 – *the) Facade of the 1st House. b) Facade of the 2nd House.*
Source: Author (2024).

provided by the users of the buildings who oversaw the construction. The 1st House is designed in resistant masonry on the inside, covered in wood with ceramic tiles and with the porch roof supported by reinforced concrete pillars. The 2nd House was designed entirely in resistant masonry and with the roof in wood with ceramic tiles.

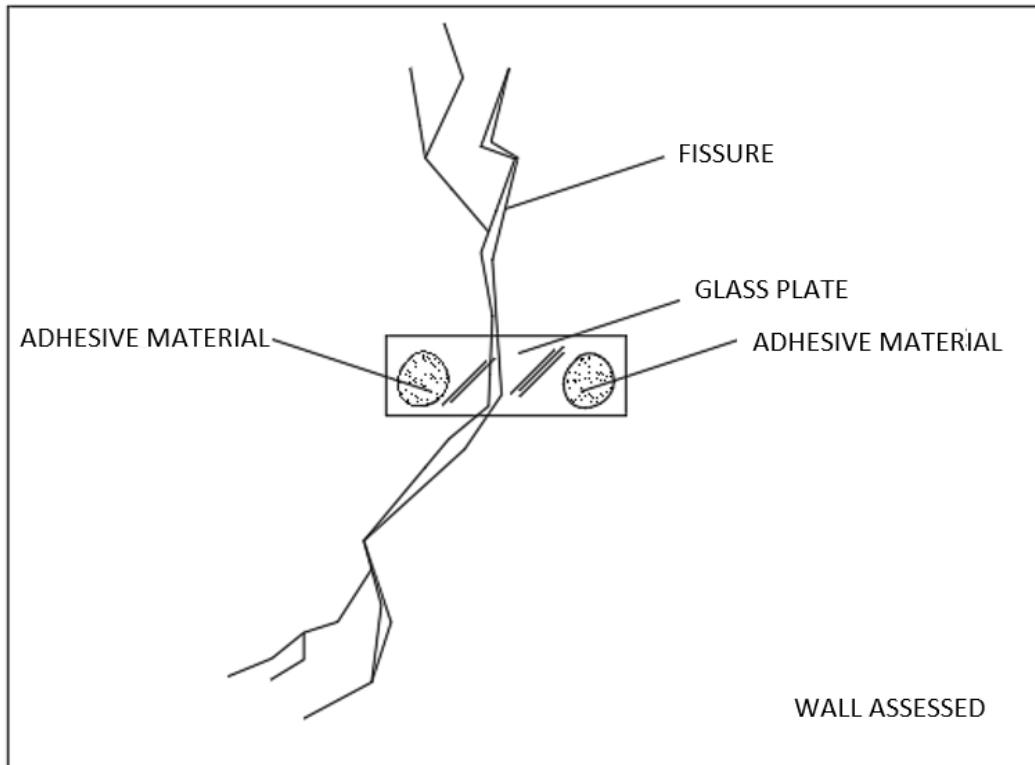
To monitor the cracks, a technique was used to place thin glass plates transverse to the crack and fixed with epoxy resin. The purpose of the plate is to serve as a sacrificial material in case the crack shows any activity. At the end of the monitoring, it should be checked whether the glass plate is broken or not; a diagram of this application is shown in Figure 2. During the inspections, photographic records of the cracks were prepared with their respective plates, with the aim of having a visual record of their situation so that they can be compared.

Figure 2 – *Installation diagram of monitoring boards.*
Source: Author (2024).

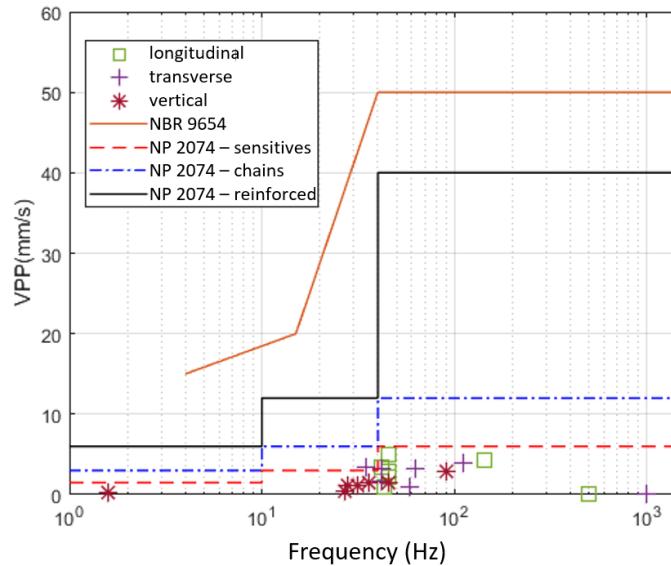
Given the conditions presented and considering the results in Figure 6, it can be concluded that the behavior of the houses analyzed in this study during dismantling corroborates the criteria established in NP 2074 (2015). As can be seen in Figure 6, the results measured have only one result above the threshold between the VPP of sensitive and current buildings and several of the other results are relatively close to this threshold. Considering that there are no specific criteria for classifying buildings and all the other variables that are intrinsic to the problem, the results presented show agreement between the classification of buildings, the choice of cracks to be monitored and the results and requirements of NP 2074 (2015).

When analyzing Figure 6 in terms of NBR 9653 (2018), the results obtained in the monitoring are very far from the limits established in this standard for VPP. Therefore, using its criteria, the recorded activities of the two cracks could not be associated with the dismantling.

Figure 6 – PPV(mm/s) × Particle oscillation frequency (Hz).

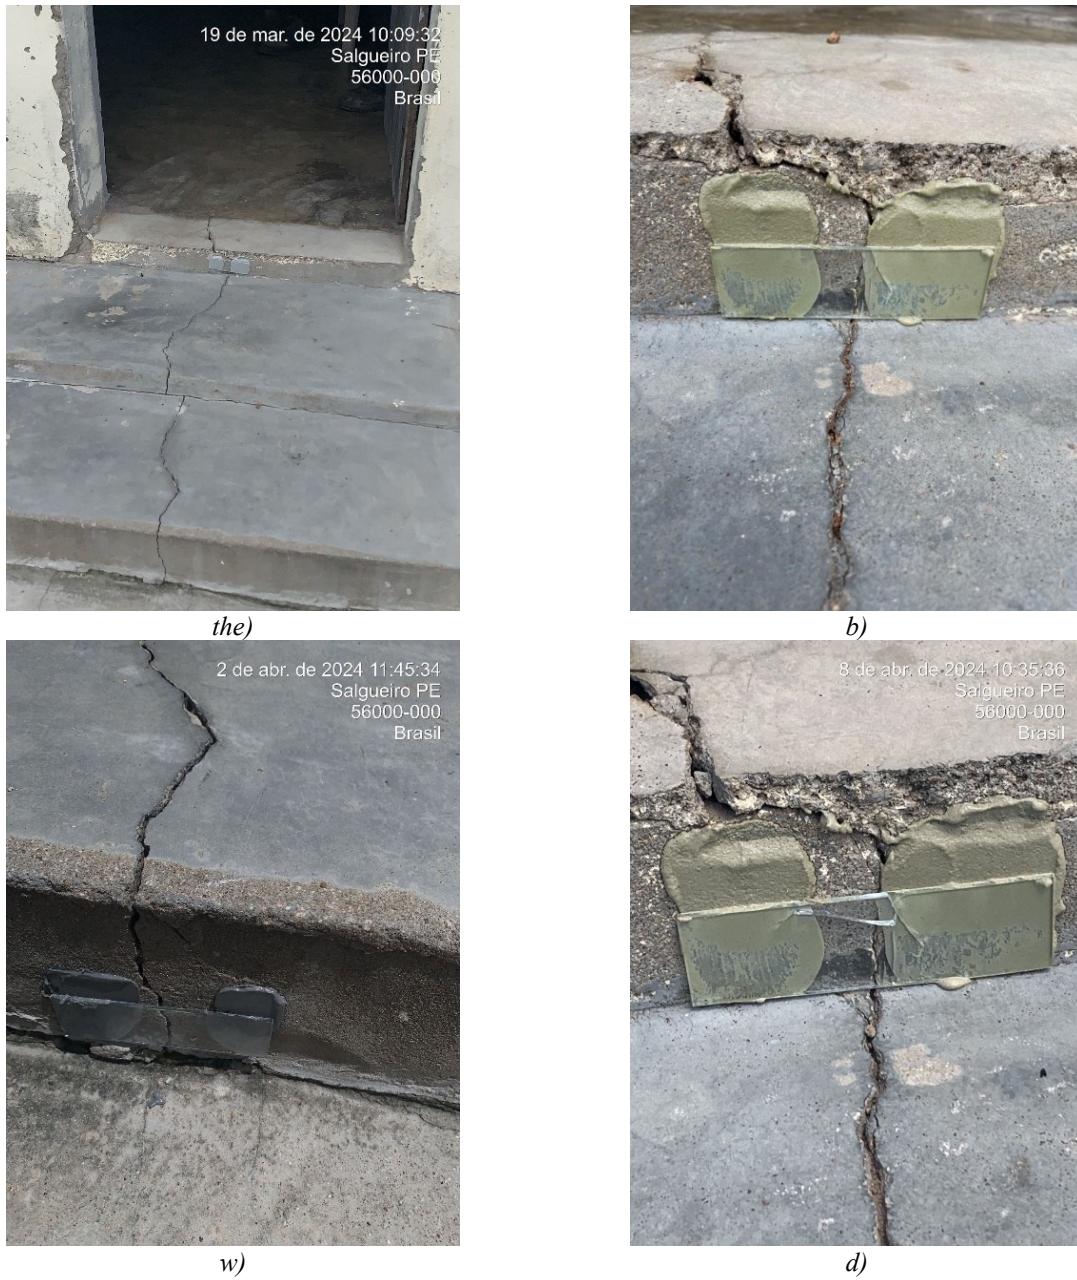
During the preliminary inspection, it was found that, although the two houses were within the same classification, the 2nd House was in a more advanced state of cracking than the 1st House. Furthermore, the cracks in the 2nd House that suffered activity were chosen because they were in two sensitive regions. The crack shown in Figure 6 is in the staircase, as can be seen, this crack runs the entire length of the staircase, which already had problems with its integrity before the dismantling operations. The crack shown in Figure 7 is located above a door that does not have a lintel. Lintels are essential elements in masonry openings, with the function of adequately transmitting the forces along the wall. Furthermore, it was also found that this wall receives loads from the roof, contributing to its selection.

Figure 7 – Cracks in the stairs of the 2nd house. *the) 03/19/2024. b) 03/25/2024. c) 04/02/2024 d) 04/08/2024.*
Source: Author (2024).

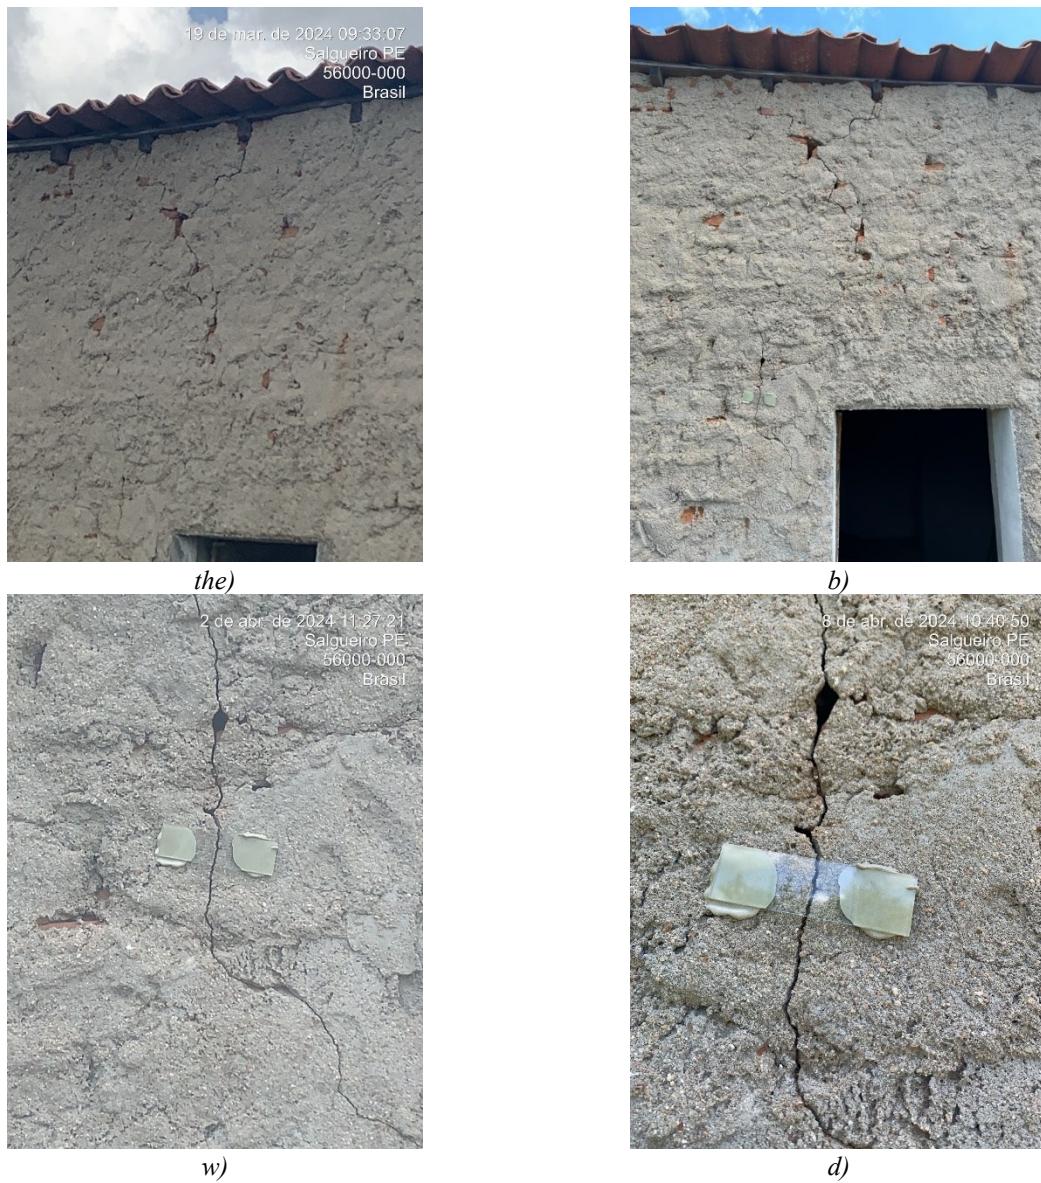
Figure 8 – Cracks in the facade cladding of the 2nd house. a) 19/03/2024. b) 25/03/2024. w) 02/04/2024. d) 08/04/2024.
