ISSN: 2447-3359

REVISTA DE GEOCIÊNCIAS DO NORDESTE

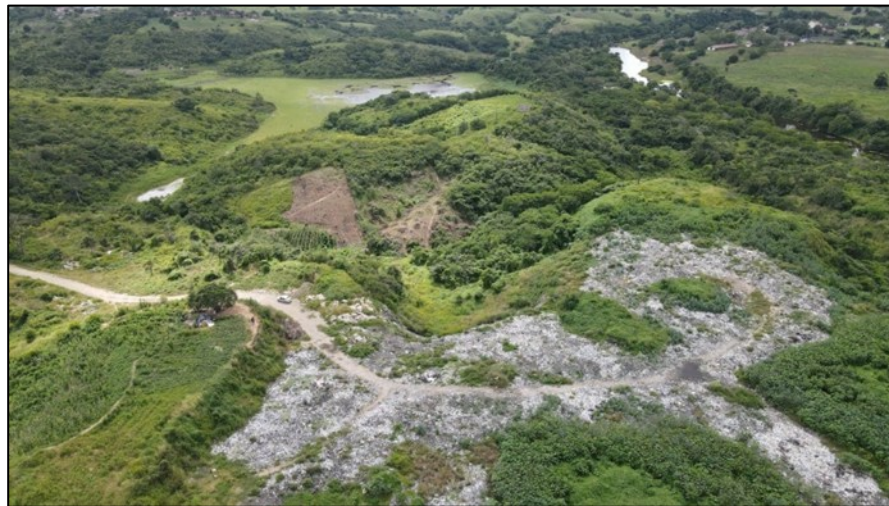
Figure 3 – Vegetation cover of the dump.  
Source: Environmental and Sustainability Management of Lagoa do Carro – PE (2022).

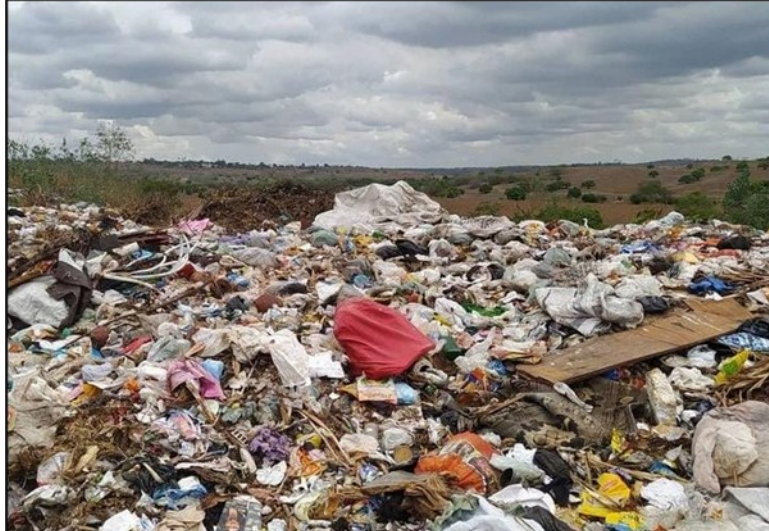
*Figure 4 – View of the municipal dump of Lagoa do Carro after closure (2020).*  
*Source: Department of Environment and Sustainability of Lagoa do Carro – PE (2020).*

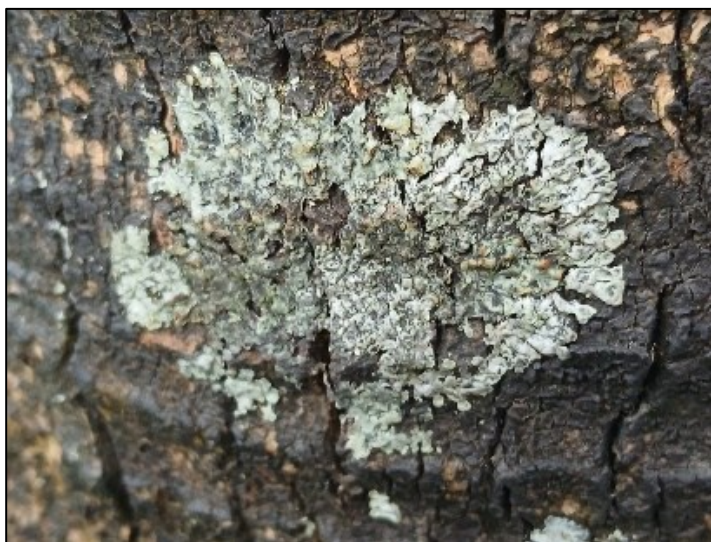
*Figure 6 – Lichen collected in the area of the Lagoa do Carro dump – PE.  
Source: Authors (2024).*

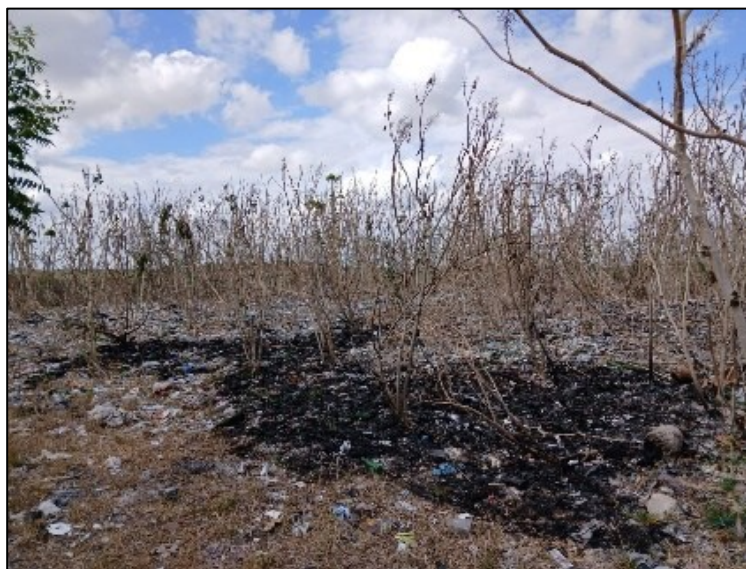
*Figure 7 – Record of spontaneous burning at the Lagoa do Carro dump – PE.  
Source: Authors (2025).*

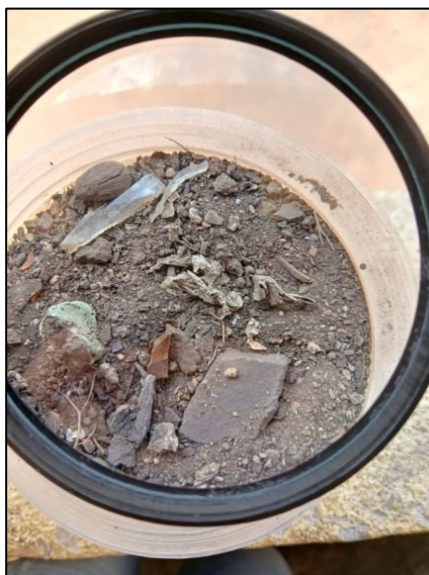
*Figure 8 – Soil sample from the Lagoa do Carro dump observed under magnification.  
Source: Authors (2025).*

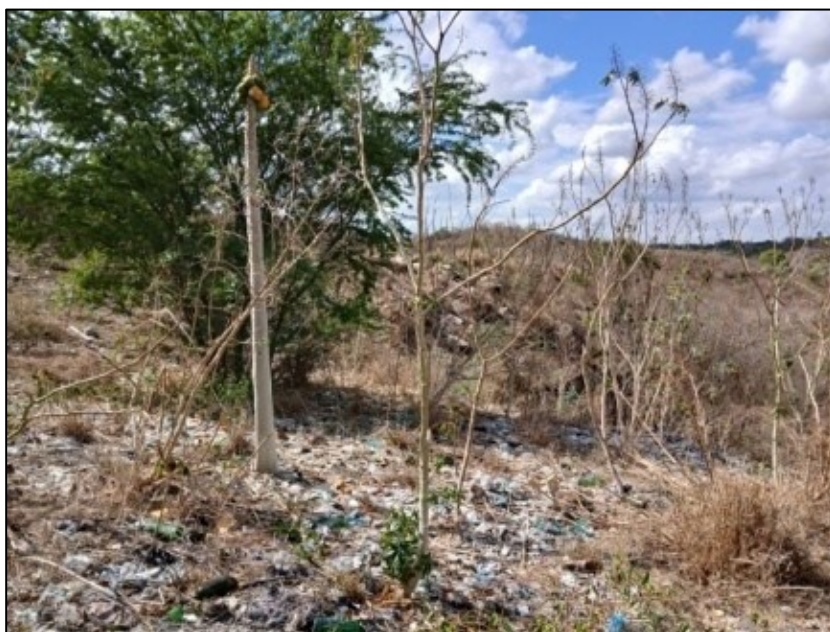
*Figure 9 – Papaya tree cultivated in the area of the Lagoa do Carro dump – PE.  
Source: Authors (2024).*

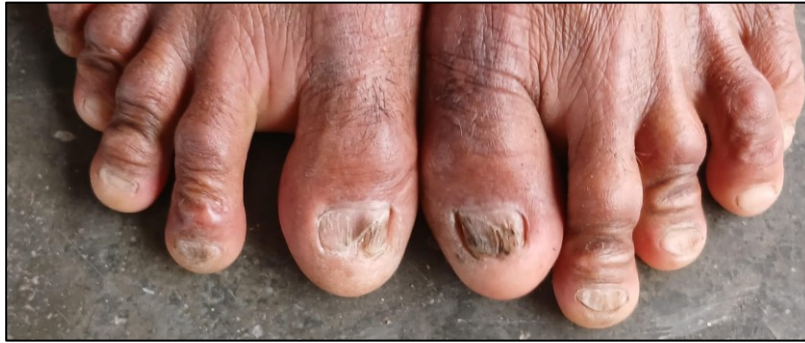
Figure 11 – Nail of a fisherman from the local community showing signs of fungal contamination.  
Source: Authors (2024).
